**Flood Control Project Maintenance
Levee Inspections**

Fall 2018 Levee Maintenance Deficiency Summary Report

**Flood Control Project Maintenance
Levee Inspections****LMA District Cover Sheet****Fall 2018 Levee Inspection Results****Levee District No. 0001 (Glenn County)**

Levee District No. 0001 (Glenn County)

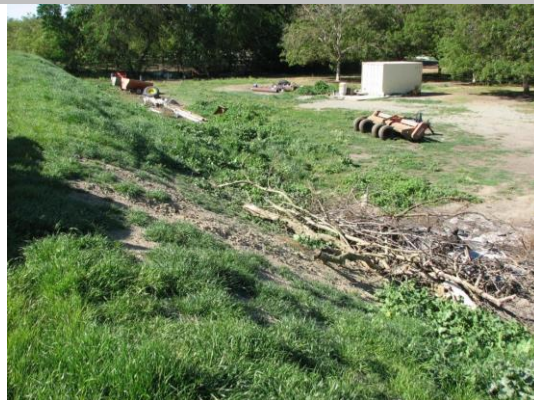
Photo 1 of 1 : FA_2018_LD0001G_432_73_20180905_00027.jpg

View of the prunings pile and ag equipment at the landside toe.

LM Start	0.05	Rating **	M	Issue No.	40
LM End	0.05	Issue Type +	En	Location *	LS
Category	Earthen Levee			GPS Latitude/Longitude	
				Start	End
Item	Encroachments			39.477833 °	39.477833 °
				-122.017484 °	-122.017484 °
DWR ID	DWR_LD0001G_01_s_2016_40				
Comment Code					
PR : Prunings					
Inspector Comment					
Remove prunings at LS toe.

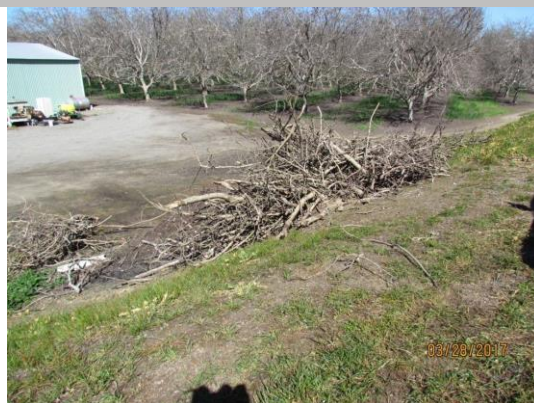
Photo 1 of 1 : FA_2018_LD0001G_432_40_20180905_00010.jpg

View of the prunings along the landside slope and toe.

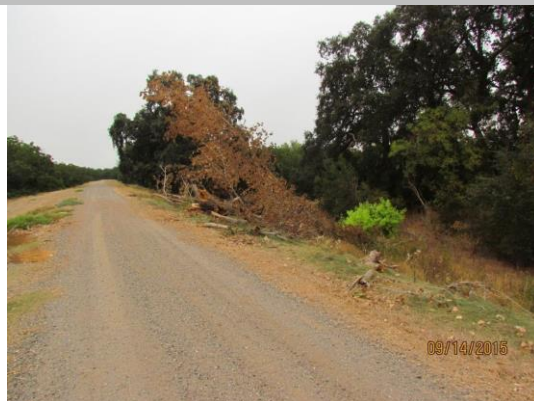
Photo 1 of 2 : FA_2018_LD0001G_432_41_20180905_00011.jpg

LM Start	0.25	Rating **	M	Issue No.	41
LM End	0.25	Issue Type +	Ma	Location *	WS
Category	Earthen Levee			GPS Latitude/Longitude	
				Start	End
Item	Encroachments			39.480769 °	39.480769 °
				-122.017301 °	-122.017301 °
DWR ID	DWR_LD0001G_01_f _ 2015_41				
Comment Code					
TR : Tree or limb					
Inspector Comment					
Remove tree from the waterside slope.

View of the tree on the waterside slope.

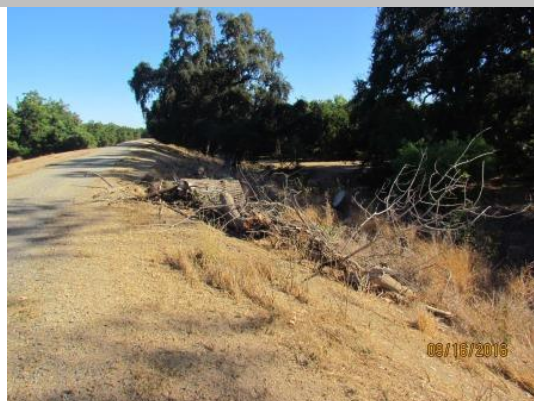
Photo 2 of 2 : FA_2018_LD0001G_432_41_20180905_00012.jpg

View of the fallen tree on the waterside slope looking upstream.

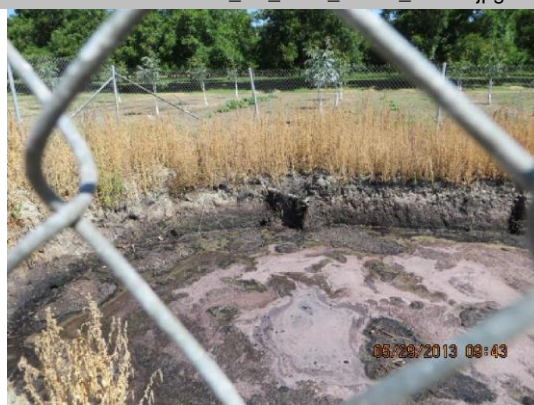
Photo 1 of 3 : UCIP_FA_2018_14324_23564.jpg

LM Start	0.77	Rating **	M	Issue No.	396	
LM End	0.77	Issue Type +	En	Location *		
Category	Supplemental			GPS Latitude/Longitude		
				Start		End
Item	DWR UCIP Field Study			39.487806 °		39.487806 °
				-122.019414 °		-122.019414 °
DWR ID	22893					
Comment Code						
Inspector Comment						
FS_ID:14324 DS_ID:22893 EP_NO: 11782 Repair Type: Non-Urgent Crossing Status: Found UCIP Comments: 5/29/2013 - Siphon breaker missing from WS shoulder (W. Wylie - DWR UCIP) FIELD_STRUCT_DESC: 3-inch galvanized steel water pipe through the levee, 2 feet below the crown. There is a hose bib style siphon breaker on the waterside (WS) shoulder. A pipe runs from the concrete sump next to the barn on the landside (LS) to a cesspool off of the WS toe. (Permit No. 11782, 1976 - Carriere Brothers). [Additional Reference(s): DWR Levee Log, 1992]. FS Date: 5/29/2013

3-inch pipe at cesspool off WS toe.

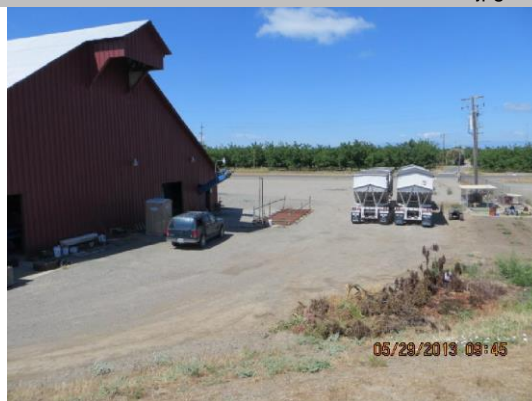
Photo 2 of 3 : UCIP_FA_2018_14324_23563.jpg

Concrete sump next to barn off LS toe.

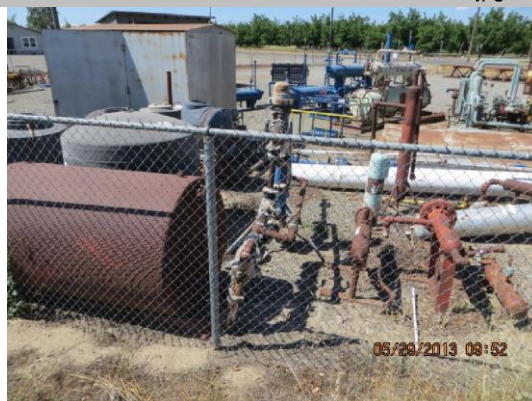
Photo 1 of 3 : UCIP_FA_2018_14325_23568.jpg

LM Start	0.80	Rating **	M	Issue No.	397
LM End	0.80	Issue Type +	En	Location *	
Category	Supplemental			GPS Latitude/Longitude	
				Start	End
Item	DWR UCIP Field Study			39.488160 °	39.488160 °
				-122.019888 °	-122.019888 °
DWR ID	22894				
Comment Code					
Inspector Comment					
FS_ID:14325 DS_ID:22894 EP_NO: 1837 Repair Type: Non-Urgent Crossing Status: Indicator Found UCIP Comments: 5/29/2013 - Gasline appears abandoned, need to verify abandonment or mark actual pipe location. (W. Wylie - DWR UCIP) FIELD_STRUCT_DESC: 3-inch gas pipeline of an unknown material through the levee, 2 feet below the crown. Fenced in pumping plant area next to levee with appurtenances. (Permit No. 1837, 1953 - Sunray Oil Corporation). [Additional Reference(s): DWR Levee Log, 1992]. FS Date: 5/29/2013

Gas pumping plant and appurtenances.

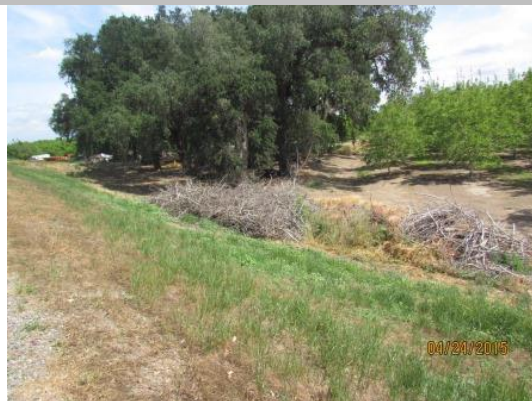
Photo 1 of 1 : FA_2018_LD0001G_432_58_20180905_00020.jpg

View of the prunings along the waterside toe.

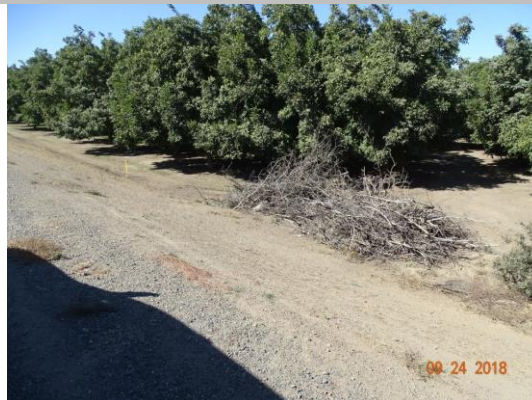
Photo 1 of 1 : FA_2018_LD0001G_432_60_20181105_00112.jpg

View of the prunings along the landside toe.

LM Start	1.28	Rating **	M	Issue No.	60
LM End	1.28	Issue Type +	En	Location *	LS
Category	Earthen Levee			GPS Latitude/Longitude	
				Start	End
Item	Encroachments			39.494368 °	39.494368 °
				-122.018048 °	-122.018048 °
DWR ID	DWR_LD0001G_01_f_2018_60				
Comment Code					
PR : Prunings					
Inspector Comment					
Remove the prunings from the landside toe.

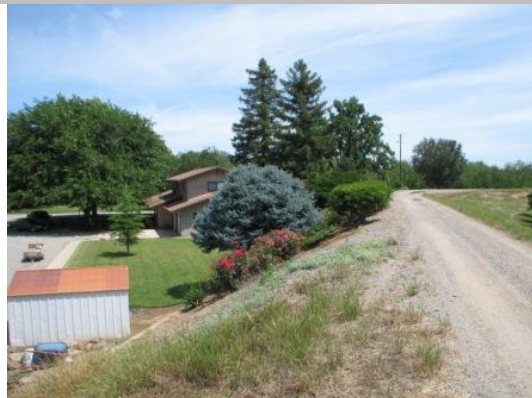
Photo 1 of 1 : FA_2018_LD0001G_432_6_20180905_00002.jpg

View of the permitted landscape on the landside slope of the levee.

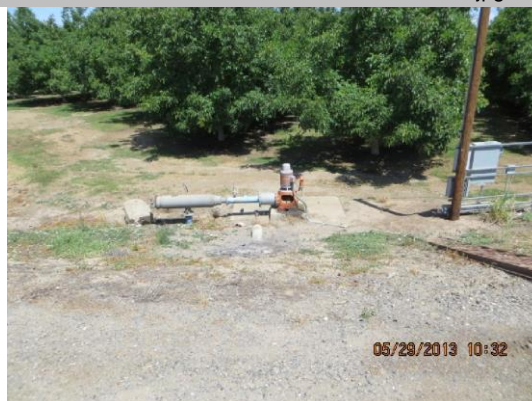
Photo 1 of 2 : UCIP_FA_2018_14331_23579.jpg

LM Start	2.22	Rating **	M	Issue No.	401	
LM End	2.22	Issue Type +	En	Location *		
Category	Supplemental			GPS Latitude/Longitude		
				Start	End	
Item	DWR UCIP Field Study			39.501690 °	39.501690 °	
				-122.006100 °	-122.006100 °	
DWR ID	22898					
Comment Code						
Inspector Comment						
FS_ID:14331						
DS_ID:22898						
EP_NO: 5717A						
Repair Type: Non-Urgent						
Crossing Status: Found						
UCIP Comments: Pipe abandoned and should be done so properly.						
FIELD_STRUCT_DESC: 8-inch asbestos cement irrigation pipe sleeved						
through a 12-inch pipe through the levee, 5 feet below the crown. Pump						
located on the landside (LS). Meter pole located on the LS toe. Guy						
wire anchor in LS slope. (Permit No. 5717-A, 1969 - W. A. Carriere).						
[Additional Reference(s): DWR Levee Log, 1992].						
FS Date: 5/29/2013

Pump at LS toe with no connection to 8-inch pipe.

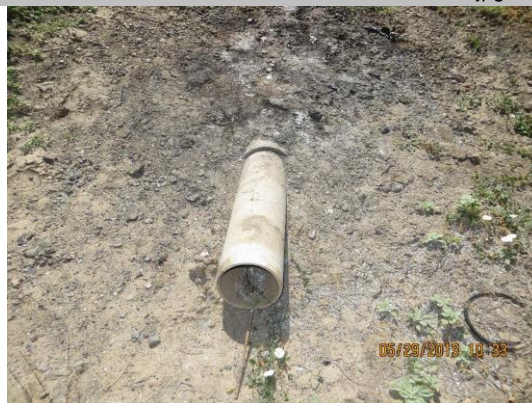
Photo 2 of 2 : UCIP_FA_2018_14331_23578.jpg

8-inch pipe visible at LS toe.

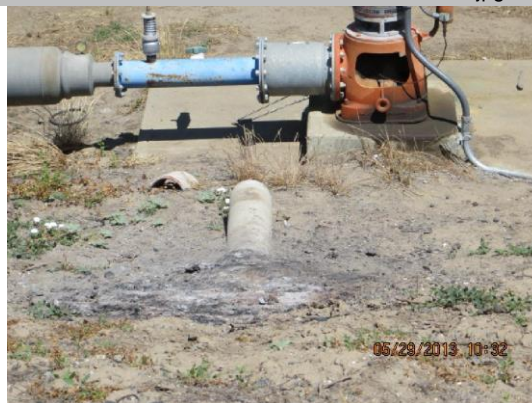
Photo 2 of 3 : UCIP_FA_2018_14332_23581.jpg

LM Start	2.22	Rating **	M	Issue No.	402
LM End	2.22	Issue Type +	Ma	Location *	
Category	Supplemental			GPS Latitude/Longitude	
				Start	End
Item	DWR UCIP LMA Responsibility			39.501690 °	39.501690 °
				-122.006099 °	-122.006099 °
DWR ID	22944				
Comment Code					
Inspector Comment					
FS_ID:14332 DS_ID:22944 EP_NO: N/A Repair Type: Non-Urgent Crossing Status: Found UCIP Comments: Appears abandoned and should be done so properly. FIELD_STRUCT_DESC: *ABANDONED* 8-inch drainage pipe of an unknown material sleeved through a 12-inch pipe of an unknown material through the levee, 9.5 feet below the crown. Flap gate located on the waterside (WS). Pipe open on the landside (LS). [Additional Reference(s): USACE Sacramento O&M Manual 140, May 1960, (HLM 2.27)]. FS Date: 5/29/2013

Pipe next to pump at LS toe.

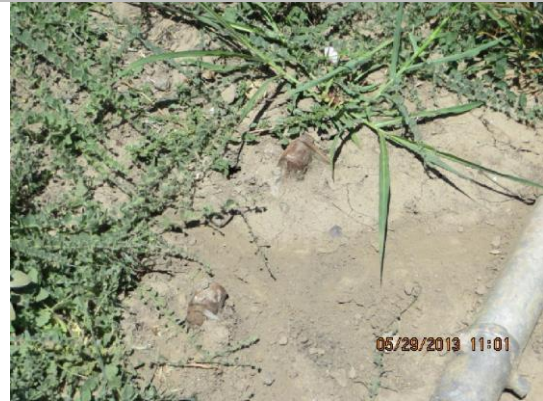
Photo 1 of 2 : UCIP_FA_2018_16223_27343.jpg

LM Start	3.13	Rating **	M	Issue No.	403
LM End	3.13	Issue Type +	En	Location *	
Category	Supplemental			GPS Latitude/Longitude	
				Start	End
Item	DWR UCIP Field Study			39.513835 °	39.513835 °
				-122.010029 °	-122.010029 °
DWR ID	22901				
Comment Code					
Inspector Comment					
FS_ID:16223 DS_ID:22901 EP_NO: 9575 Repair Type: Non-Urgent Crossing Status: Found UCIP Comments: Appears to have been abandoned. Need to verify pipe was grouted/abandoned properly. FIELD_STRUCT_DESC: *ABANDONED* 12-inch drainage pipe of an unknown material through the levee, 14 feet below the crown. Flap Gate on the waterside (WS) end. (Automatic Board Order (ABO) issued as Permit No. 9575, 1974 - Franklin Emmett, Bette Lou Dillard Jr., and McIntyre). [Additional Reference(s): DWR Levee Log, 1992]. FS Date: 5/29/2013

Flap gate visible at WS toe.

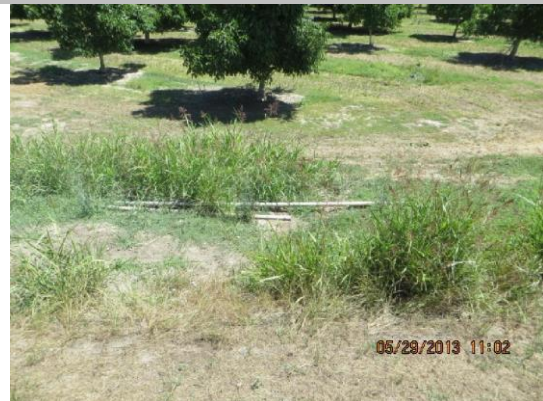
Photo 2 of 2 : UCIP_FA_2018_16223_27342.jpg

Flap gate visible at WS toe.

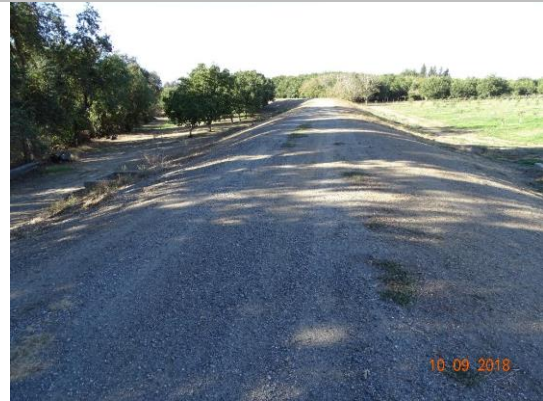
Photo 1 of 3 : UCIP_FA_2018_53006_78123.jpg

View of levee crown at the crossing.

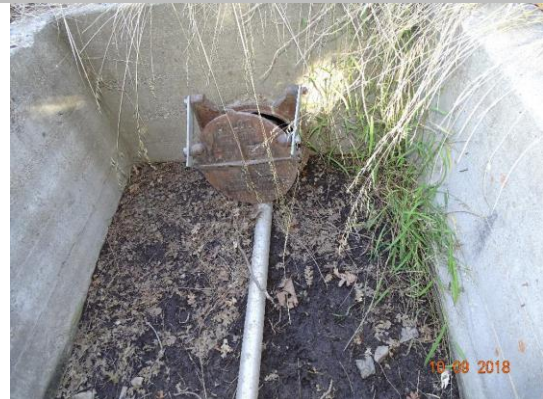
Photo 2 of 3 : UCIP_FA_2018_53006_78124.jpg

Comment Code					
Inspector Comment					
FS_ID:53006 DS_ID:22904 EP_NO: 9572 Repair Type: Urgent Crossing Status: Found UCIP Comments: 10/9/2018 No change to the crossing status. Flap gate on WS cannot be fully closed due to a 3-inch pipe through drainage pipe crossing the levee. Water is supplied from a well on LS via 3-inch pipe to the WS for irrigation/drinking purposes. Owner will need to remove obstruction to allow proper flap gate closure. (O.Yakimov - DWR)12/21/2016 Flap gate on WS does not appear to be broken however, flap gate does not fully close due to a 3-inch aluminum pipe sleeve through larger pipe. Need to remove 3-inch pipe in order to have WS flap gate close and to be compliant with Title 23. (O. Magana - DWR UCIP)05/29/2013 Broken flap gate and Concrete headwall on LS toe possibly tilting. Also a 3-inch alluminum irrigation line through the pipe. (W. Wylie - DWR UCIP) FIELD_STRUCT_DESC: 18-inch steel drainage pipe through the levee, 7.3 feet below the crown. Flap gate in 6-inch by 6-inch concrete box located on the waterside (WS) end. Concrete headwall located on the landside (LS) toe. (18-inch pipe [HLM 4.05] authorized under Automatic Board Order (ABO) issued as Permit No. 9572, 1974 - Henry and Annabel B. Smith). [Additional Reference(s): DWR Levee Log, 1992. USACE Sacramento O&M Manual 140, May 1960, (HLM 4.05)]. FS Date: 10/9/2018 3:27:06 PM

3-inch pipe obstructs flap gate from complete closing.

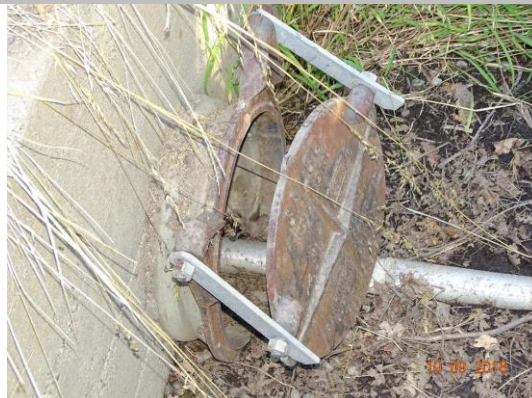
Photo 3 of 3 : UCIP_FA_2018_53006_78125.jpg

3-inch pipe obstructs flap gate from complete closing.

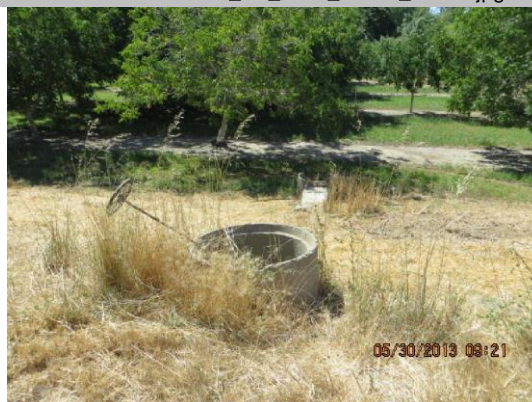
Photo 2 of 3 : UCIP_FA_2018_51284_23593.jpg

Comment Code					
Inspector Comment					
FS_ID:51284 DS_ID:22906 EP_NO: 1229 Repair Type: Non-Urgent Crossing Status: Found UCIP Comments: 12/21/2016 same as last inspection. Crossing has been modified from original permit. Need to contact owner to determine permit number issued for modification and to determine current status of crossing. Crossing has been downgraded from Urgent to Non-Urgent due to no damage observed on levee slopes or crown. (O. Magana - DWR UCIP)05/30/2013 Gate valve broken off in concrete standpipe on WS shoulder. 8-inch aluminum pipe sleeved through pipe prevents closure of 18-inch pipe. All concrete standpipes have been modified or broken. (W. Wylie - DWR UCIP) FIELD_STRUCT_DESC: 16-inch concrete (not 18-inch asphalt dipped steel as referenced in permit or USACE O&M manual) irrigation pipe through the levee, 8.6 feet below the crown. Gate valve in concrete well located on the waterside (WS) slope. Pump, service pole, engine, and fuel tank 48-inch, and standpipe are located on the toe of the landside (LS) slope (Permit No. 1229, 1947 - R. T. Miller). [Additional Reference(s): DWR Levee Log, 1992. USACE Sacramento O&M Manual Unit 140, May 1960, (HLM 4.33)]. FS Date: 12/21/2016

Gate valve in Concrete riser on WSs houlder.

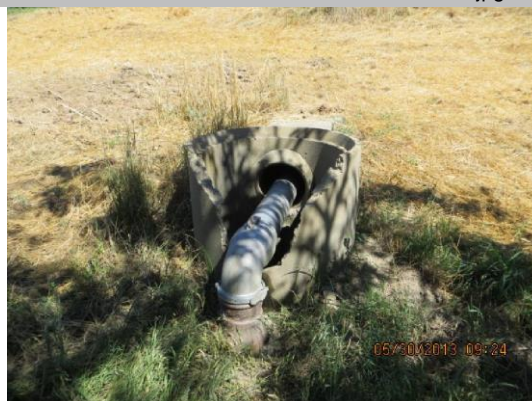
Photo 3 of 3 : UCIP_FA_2018_51284_23592.jpg

8-inch pipe sleeved through 16-inch pipe at LS toe.

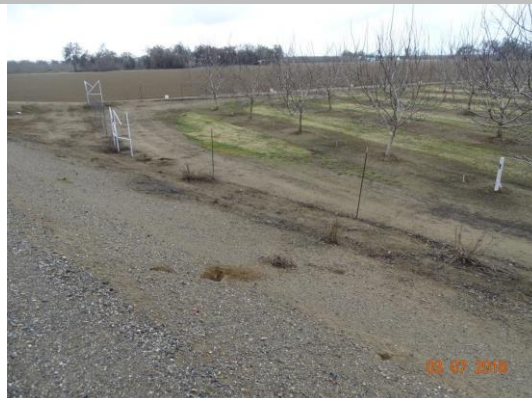
Photo 1 of 1 : FA_2018_LD0001G_432_70_20180905_00026.jpg

View of the rodent holes along the landside slope.

LM Start	5.77	Rating **	M	Issue No.	70
LM End	5.77	Issue Type +	Ma	Location *	LS
Category	Earthen Levee			GPS Latitude/Longitude	
				Start	End
Item	Animal Control			39.544087 °	39.544087 °
				-122.000863 °	-122.000863 °
DWR ID	DWR_LD0001G_01_s_2018_70				
Comment Code					
A3 : No rodents visible, but rodent burrows visible; need to backfill and compact or grout burrows.					
Inspector Comment					
Repair the rodent holes along the landside slope.

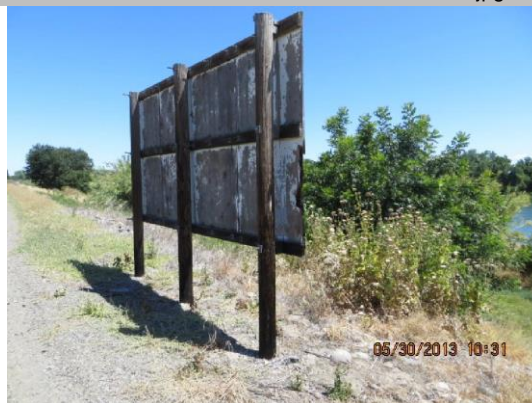
Photo 2 of 2 : UCIP_FA_2018_14352_23608.jpg

FS_ID:14352
DS_ID:22911
EP_NO: 5118
Repair Type: Non-Urgent
Crossing Status: Indicator Found
UCIP Comments: New gasoline markers should be installed as existing signage has been sun faded
FIELD_STRUCT_DESC: 1 of 2: 12.75-inch high pressure gas pipeline of an unknown material through the levee, 3 feet below the crown.
(Permit No. 5118, 1965 - PG&E). [Additional Reference(s): DWR Levee Log, 1992].
FS Date: 5/30/2013

Gasline sign on WS shoulder.

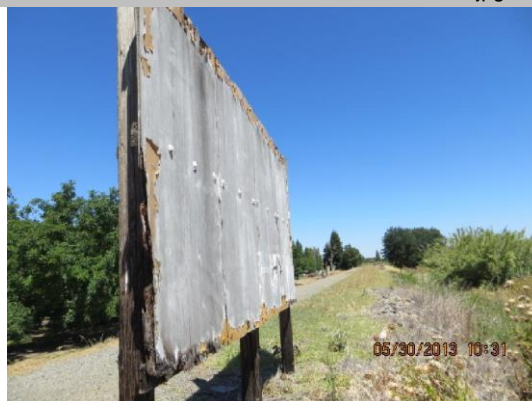
Photo 1 of 1 : UCIP_FA_2018_16224_27345.jpg

LM Start	6.18	Rating **	M	Issue No.	407	
LM End	6.18	Issue Type +	En	Location *		
Category	Supplemental			GPS Latitude/Longitude		
				Start	End	
Item	DWR UCIP Field Study			39.549938 °	39.549938 °	
				-122.002110 °	-122.002110 °	
DWR ID	22937					
Comment Code						
Inspector Comment						
FS_ID:16224						
DS_ID:22937						
EP_NO: 5118						
Repair Type: Non-Urgent						
Crossing Status: Indicator Found						
UCIP Comments: Pipe needs new gasline markers as sign on WS shoulder is sunbleached and cannot be read.						
FIELD_STRUCT_DESC: 2 of 2: 12.75-inch high pressure gas pipeline of an unknown material through the levee, 3 feet below the crown. Gas line sign on the waterside (WS) shoulder. (Permit No. 5118, 1965 - PG&E). [Additional Reference(s): DWR Levee Log, 1992].						
FS Date: 5/30/2013

Gasline sign on WS shoulder.

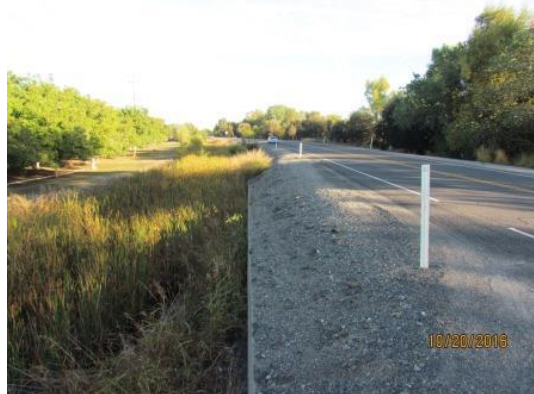
Photo 2 of 2 : FA_2018_LD0001G_432_69_20180905_00025.jpg

Another view of the ag ditch looking upstream.

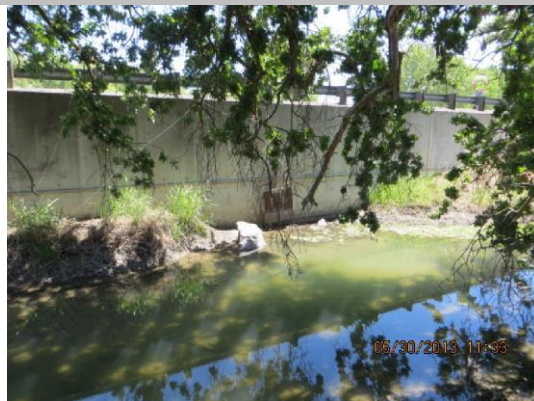
Photo 1 of 2 : UCIP_FA_2018_14373_23655.jpg

LM Start	6.73	Rating **	M	Issue No.	408
LM End	6.73	Issue Type +	En	Location *	
Category	Supplemental			GPS Latitude/Longitude	
				Start	End
Item	DWR UCIP Field Study			39.557721 °	39.557721 °
				-122.004267 °	-122.004267 °
DWR ID	22915				
Comment Code					
Inspector Comment					
FS_ID:14373 DS_ID:22915 EP_NO: 1443A Repair Type: Non-Urgent Crossing Status: Found UCIP Comments: Pipe abandoned, but need to verify if it was abandoned properly. FIELD_STRUCT_DESC: 36-inch concrete encased irrigation pipe through the levee, 9 feet below the crown. Steel plate welded over pipe at the landside (LS) toe. 3-inch steel vent pipe on the LS toe. [Additional Reference(s): DWR Levee Log, 1992. USACE Sacramento O&M Manual 140, May 1960, (HLM 6.83)]. FS Date: 5/30/2013

Pipe with steel plate welded over end on LS of levee crown.

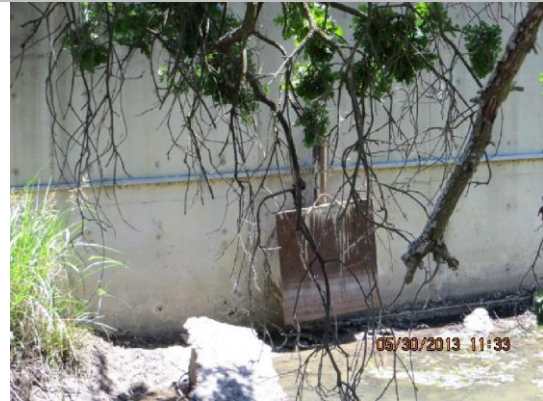
Photo 2 of 2 : UCIP_FA_2018_14373_23654.jpg

Pipe with steel plate welded over end on LS of levee crown.

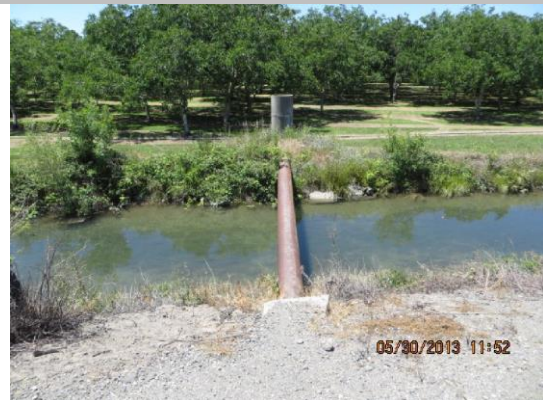
Photo 1 of 3 : UCIP_FA_2018_14384_23664.jpg

Pipe on LS toe with concrete standpipe visible.

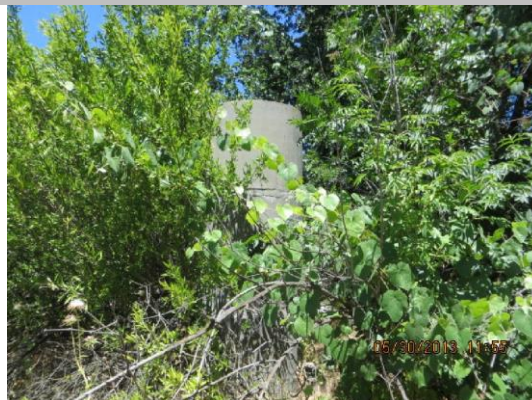
Photo 3 of 3 : UCIP_FA_2018_14384_23662.jpg

Concrete standpipe off WS toe.

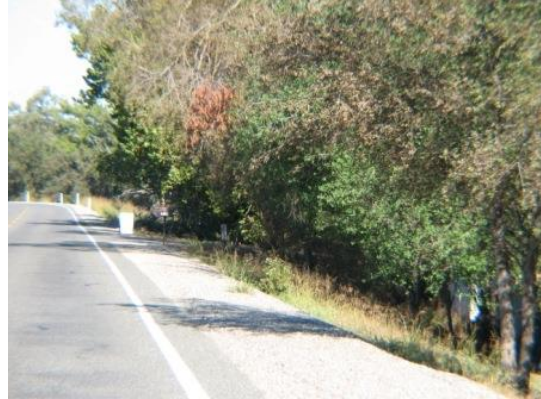
Photo 1 of 1 : FA_2018_LD0001G_432_20_20180905_00008.jpg

View of the trees and vegetation along the waterside slope of the levee.

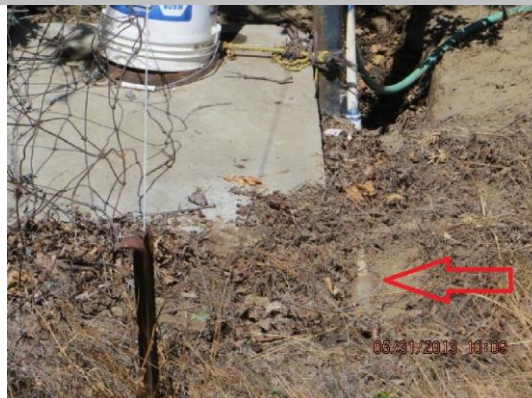
Photo 2 of 3 : UCIP_FA_2018_16204_27329.jpg

Pipe visible next to well with bucket over standpipe.

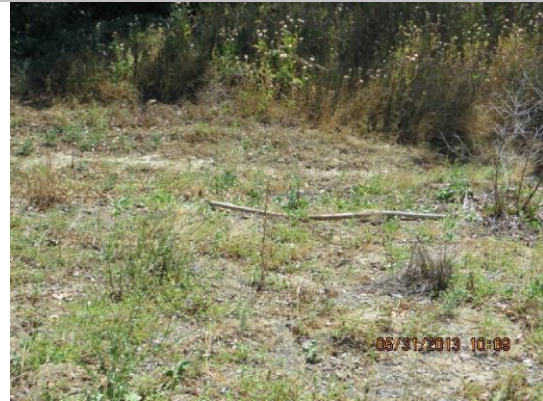
Photo 3 of 3 : UCIP_FA_2018_16204_27328.jpg

Pipe debris on WS slope may be indicator of pipe location on WS.

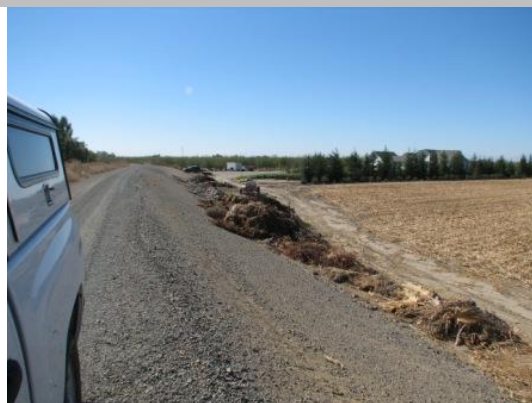
Photo 1 of 1 : FA_2018_LD0001G_432_11_20180905_00006.jpg

View of debris along the toe of the levee.

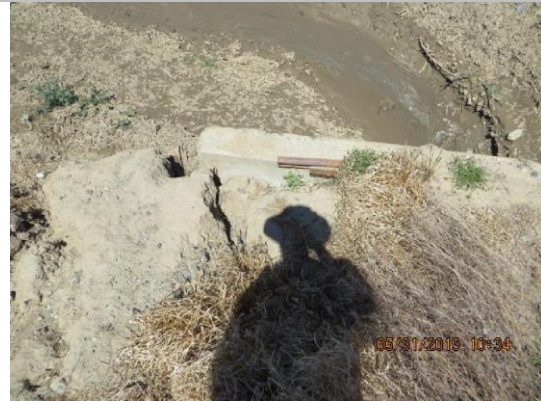
Photo 3 of 3 : UCIP_FA_2018_14390_23688.jpg

Erosion around headwall at LS toe.

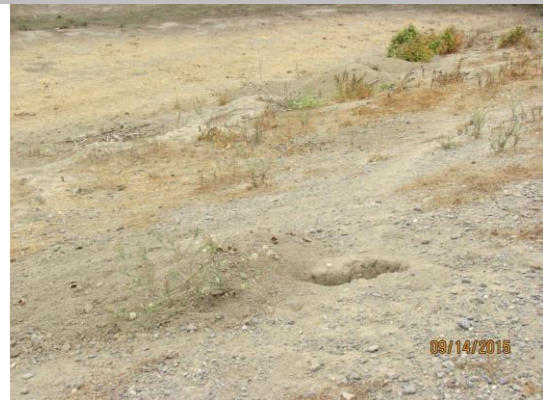
Photo 1 of 1 : FA_2018_LD0001G_432_66_20180905_00021.jpg

View of the rodent holes along the waterside slope.

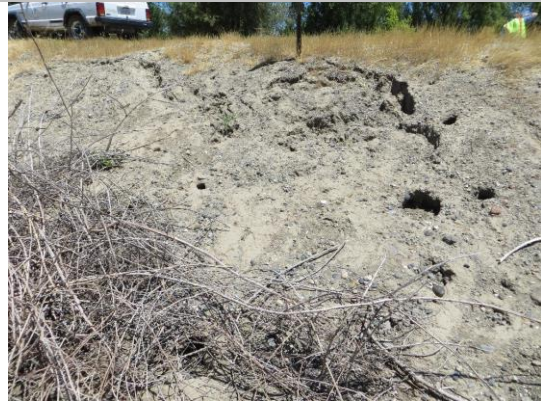
Photo 3 of 3 : UCIP_FA_2018_14567_24015.jpg

Erosion and sloughing on LS slope possibly due to rodent activity.
